# Aluminium Distribution Cabinets Resistance to Rifle Fire

**Summary:** An unusual historic paper from 1966 where the Post Master General's Headquarters Lines Section collaborated with the Department of the Army to subject aluminium distribution cabinets to ballistics testing ahead of possible rural deployment.

## ALUMINIUM DISTRIBUTION CABINETS — RESISTANCE TO RIFLE FIRE

T. N. PIMM, Grad.I.E. Aust.\*

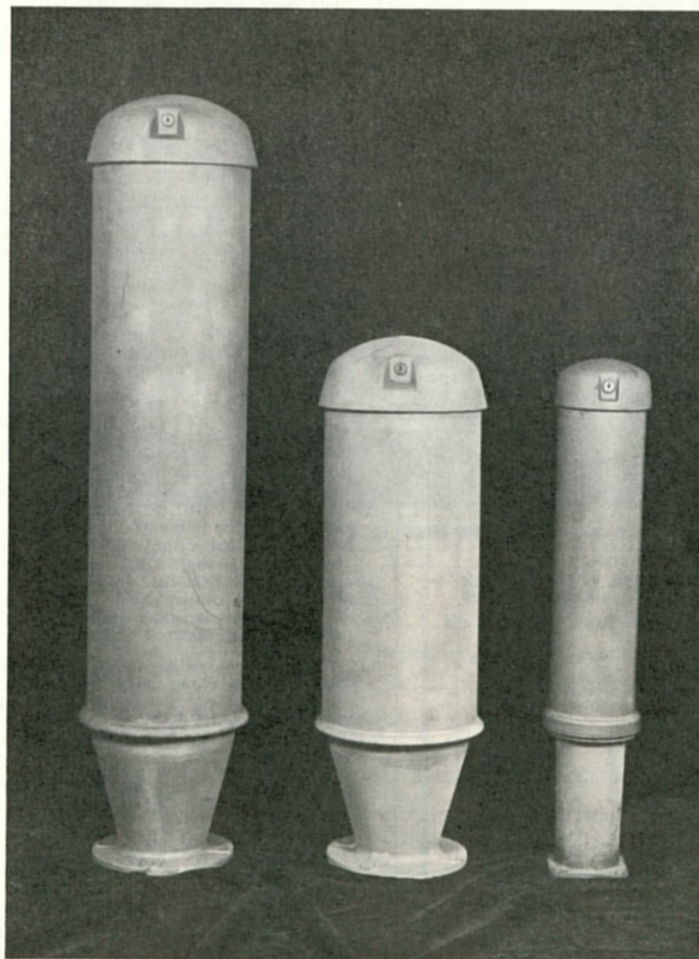
Fig. 1 — Aluminium Distribution Cabinets and Pillar. Left to Right: 1800 pair cabinet, 900 pair cabinet, 300 pair pillar.

subscribers cables and to provide cross connection facilities from main to distribution cables. The units are made of cast aluminium (BS 1490 alloy LM 6) and are available in three sizes, 300 pair, 900 pair, and 1800 pair. (See Fig. 1). The principal dimensions are given in Table 1.

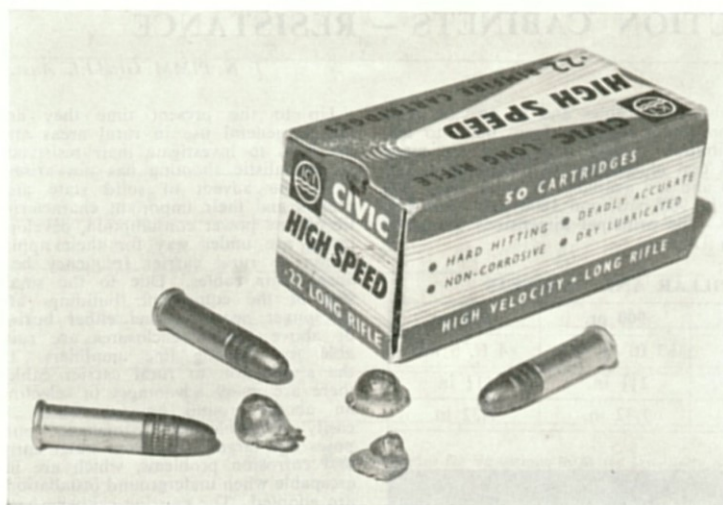
Fig. 2 — Cartridges used in Tests and Examples of Deformed Bullets after Testing.

The ranges for the 0.22 in. calibre were chosen on the basis of maximum and minimum probable firing distances. A shooter of the kind considered is unlikely to choose a target at a distance greater than 100 yards owing to the reduced chances of gaining a hit. That is, the vandal is not in the class of the keen and accurate shooter, but is in effect a casual shot who will choose an object because of its proximity and attractiveness. At the short range, the vandal is expected to have either sufficient common sense or hard earned experience to realise the danger of ricochet. A lower limit of 20 yards was therefore considered reasonable and 40 yards was chosen for an intermediate range. The cartridges used for the test were "Civic" high velocity, long rifle type (Fig. 2) with an average muzzle velocity of approximately 1,350 feet per second.

Some examples of the deformed bullets which caused this damage are shown in Fig. 2.

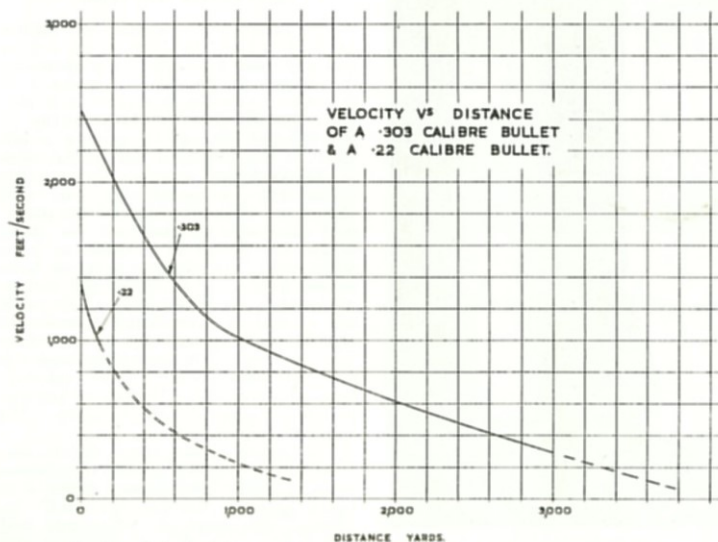
Fig. 3 — Velocity/Distance Curves for 0.303 in. and 0.22 in. Calibre Bullets.

considered. In order to obtain a high accuracy during the 0.303 in. tests it was decided to use a short range (30 yards) and to vary the charge to simulate longer shots. This then allowed accurate placing of rounds in two or three positions from full face to glancing shots. The calculated velocities were 2,230 feet per second at 100 yards and 2,030 feet per second at 200 yards (Fig. 3).

A 0.303 in. calibre bullet has this velocity at about 2,000 yards (Fig. 3) indicating the high damage potential of these bullets.

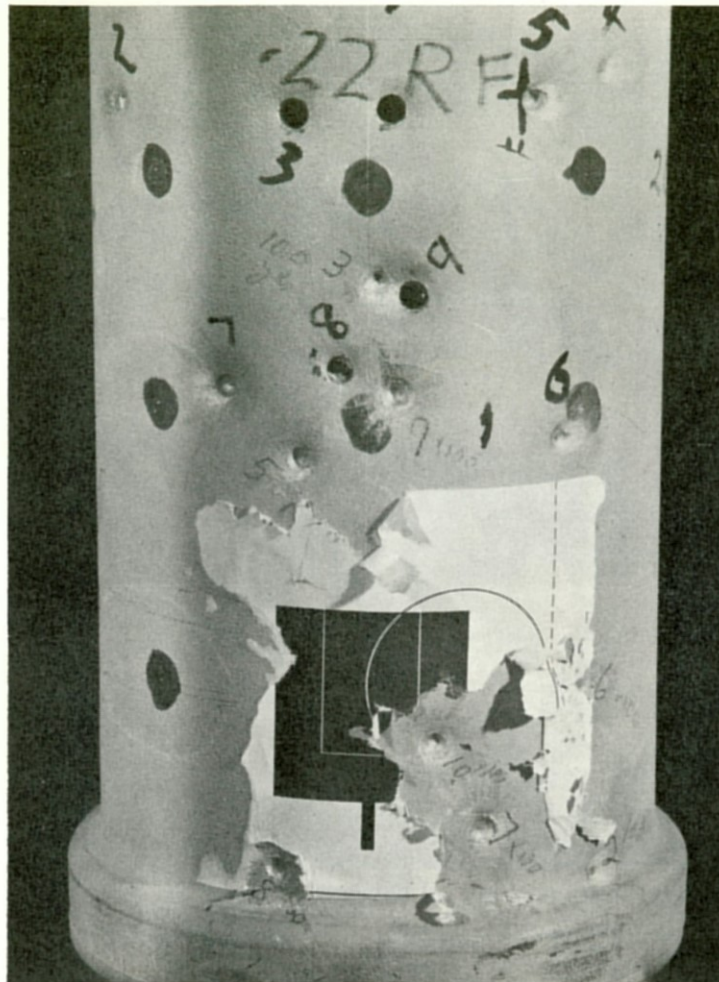
Fig. 4 — Penetration of 0.22 in Calibre Bullets on 300 Pair Cover at 20, 40 and 100 yd. Ranges. (See Table 2).

0.22 in. calibre, 20 yards Fig. 4 Top row	$\frac{1}{4}$	1223	1194	Full	Hit centre column No damage to inside surface on rear of pillar. Star shaped crack inside surface.
	1	1241	1212	Full	
	$1\frac{1}{4}$	1243	1214	$\frac{1}{8}$	
	$2\frac{1}{4}$	1251	1222	$\frac{1}{32}$

0.22 in. calibre, 40 yards Fig. 4 Centre row	$3\frac{1}{4}$	Not Rec'd.	NR	$\frac{1}{32}$	Penetration just complete  Fine tear in metal at bottom of hole. Star shaped crack inside.
	$\frac{1}{4}$	1218	1131	Full	
	$\frac{1}{2}$	1284	1197	Full	
	$1\frac{1}{2}$	1215	1128	$\frac{1}{8}$

0.22 in. calibre, 100 yards Fig. 4 Lower shots	$2\frac{1}{4}$	1145	1058	Negligible	Maximum penetration of 7 shots was $\frac{1}{16}$ in. with star shaped cracks at inside surface in 4 cases.

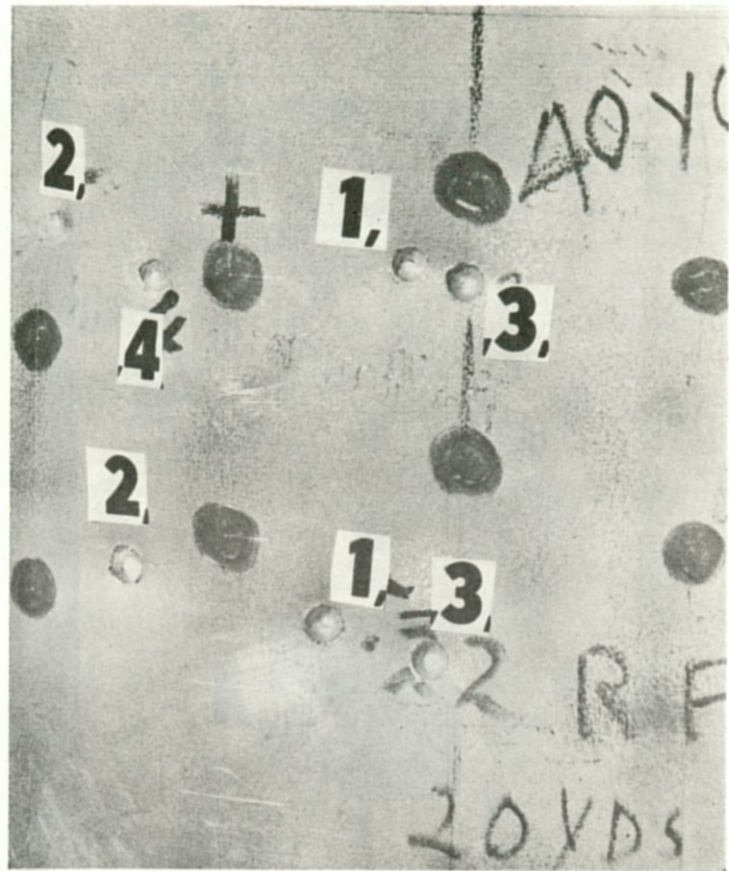
Fig. 5 — Penetration of 0.22 in. Calibre Bullets on 900 Pair Cover at 20 and 40 yd. Ranges. (See Table 3).

Circumferential Distance from Centre Line	Velocity at 30 ft. (ft. per sec.)	Striking Velocity (ft. per sec.)	Depth of Penetration (inches)	Remarks
0.22 in. calibre, 20 yards, Fig. 5 Lower row	1/4	1197	1168	5/32	Local deformation, star shaped crack inside surface.
	1	1232	1203	3/16	Slight local deformation, fine tear in metal at bottom of hole. Star shaped crack inside surface.
	3	1315	1286	3/16	Slight local deformation. Star shaped crack inside surface.

0.22 in. calibre, 40 yards, Fig. 5 Upper row	0	1236	1149	1/8	{ Local deformation to 1/8 in. between these two adjacent holes. Star shaped cracks inside surface.
	1/2	1241	1154	5/32	
	2 1/4	1212	1125	1/16	negligible deformation
	3 1/4	1225	1138	1/32	negligible deformation

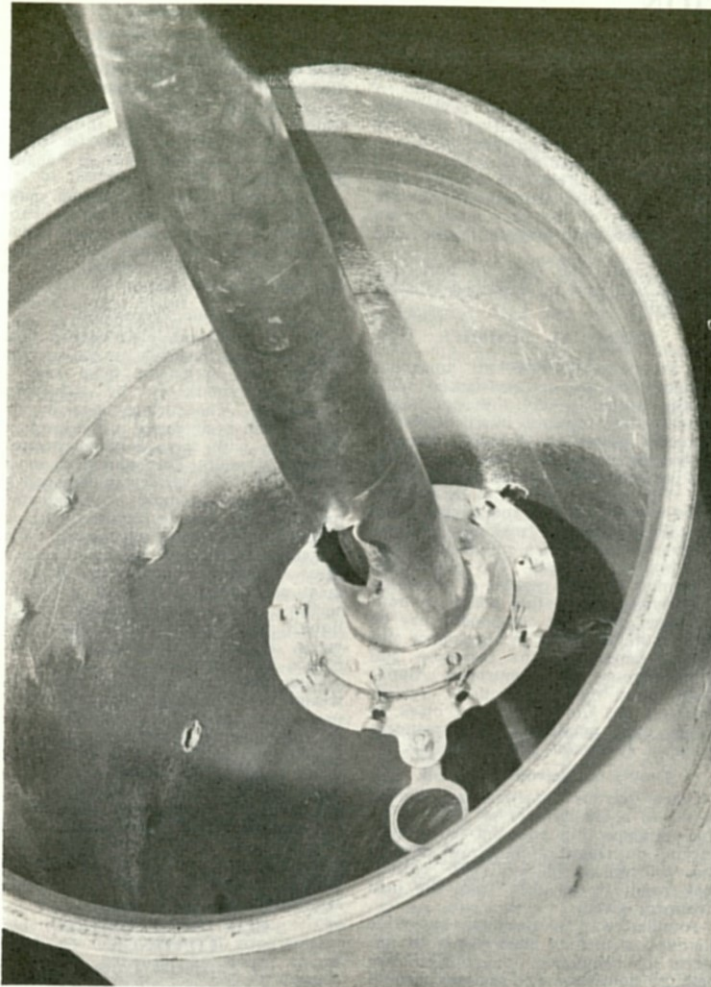
Fig. 6 — Inside Surface of a 900 Pair Cover, showing Star Shaped Cracks from Bullet Penetration.

It will be seen that even at 20 yards range the large casing was not fully penetrated by a 0.22 in. calibre bullet. The maximum penetration was approximately 3/16 in. with some associated deformation of the casing. The inside surface of the casing had, in several cases, star shaped cracks associated with the deformation of the metal (Fig. 6), and these small cracks would allow leakage of air from a pressurised container.

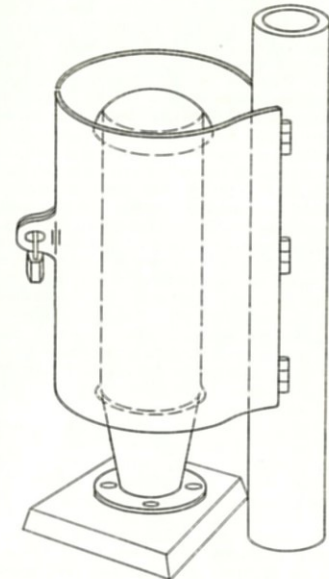
Fig. 7 — A Possible Method of Providing Additional Protection.

Consideration may be given to extra protection of the cabinets in order to avoid damage even from 0.303 in. bullets. Such protection however, would need to be of the order of  $1\frac{1}{2}$  in. of concrete or  $\frac{1}{2}$  in. steel. The cost and weight of this protection severely limits its practical use when compared to installation of a container in a manhole. If, however, the local probability of such damage could not be tolerated and manhole installation was inadvisable for other reasons, a possible method of protection is indicated in Fig. 7 where access is relatively easy and construction cost is not excessive.
